Evaluation of Thermoplastic Marking Materials

May 2008

DOT/FAA/AR-TN08/22

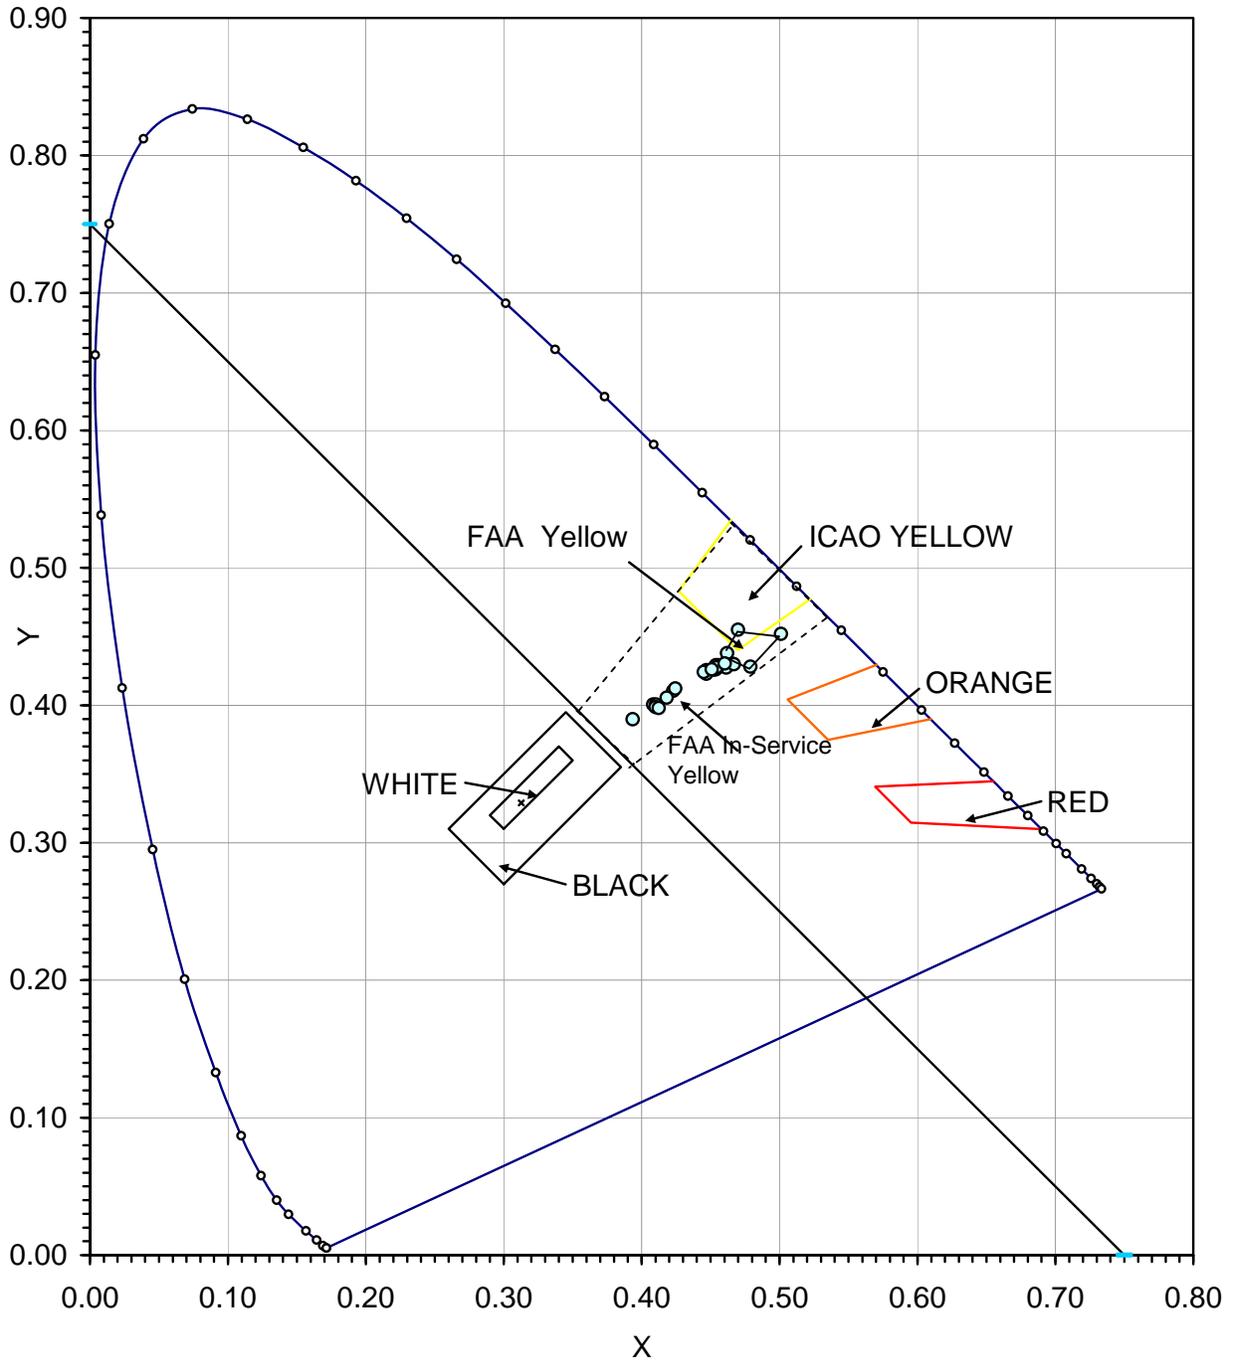
Figure A-48. Chromaticity Readings of CCRHP, Yellow Paint at EWR

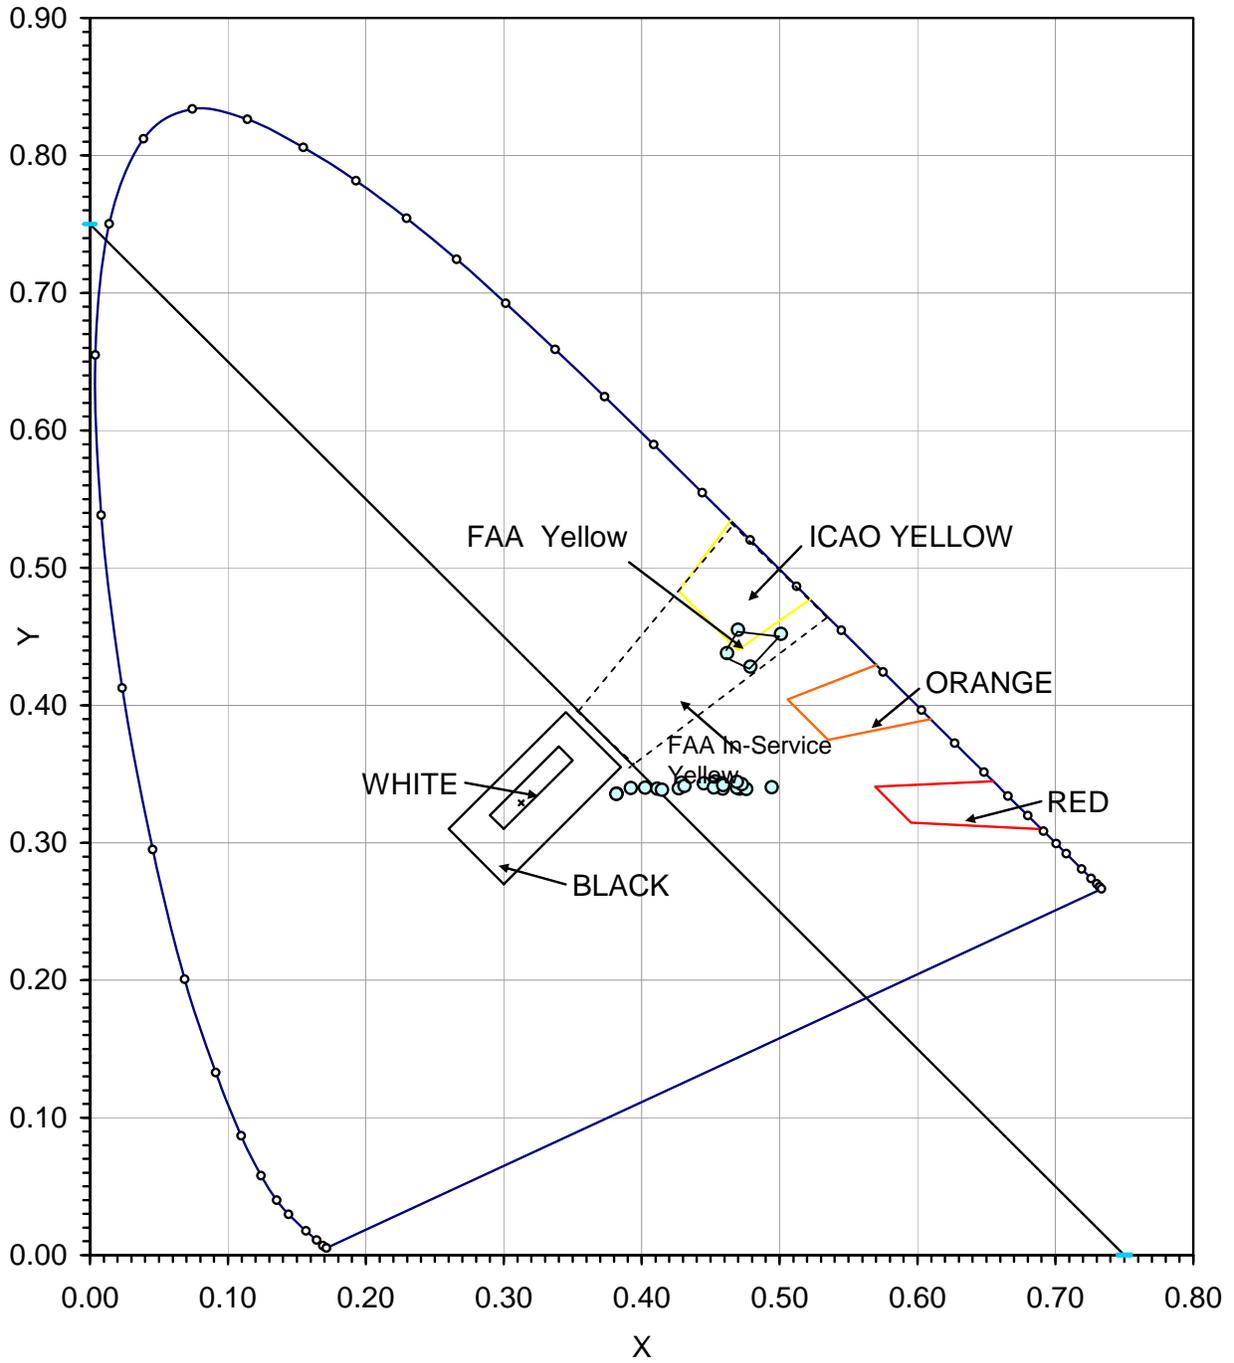
Figure A-49. Chromaticity Readings of CCRID, Red Paint at EWR

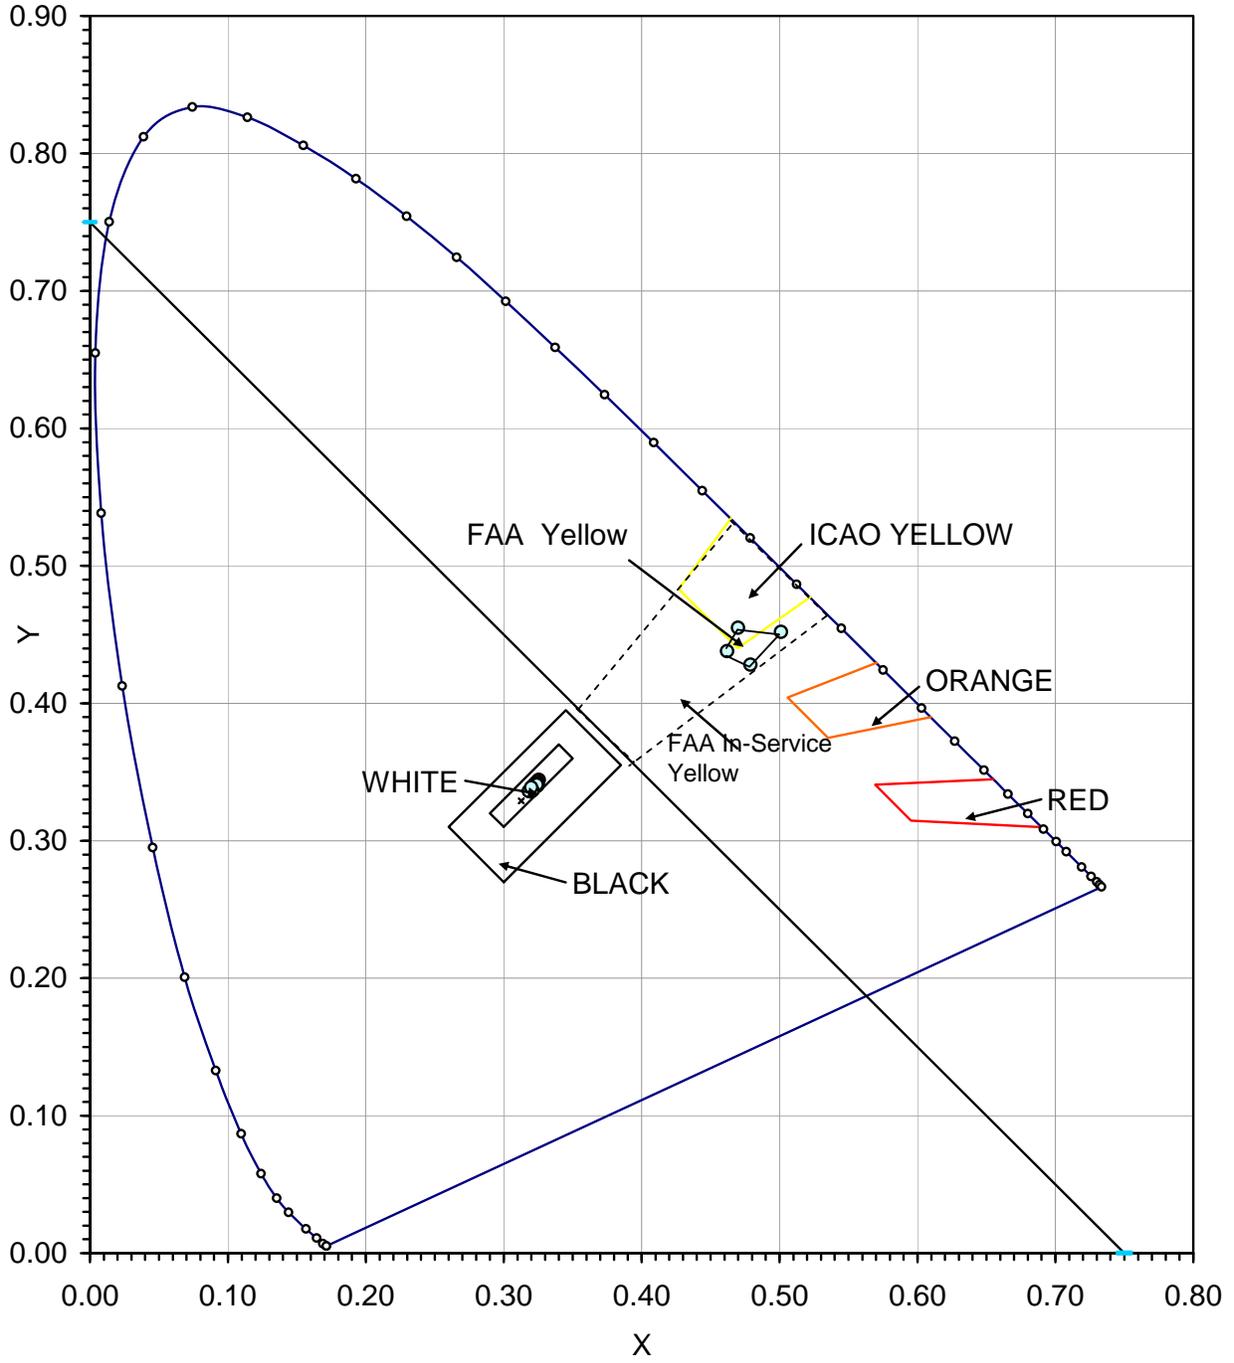
Figure A-50. Chromaticity Readings of CCRID, White Paint at EWR

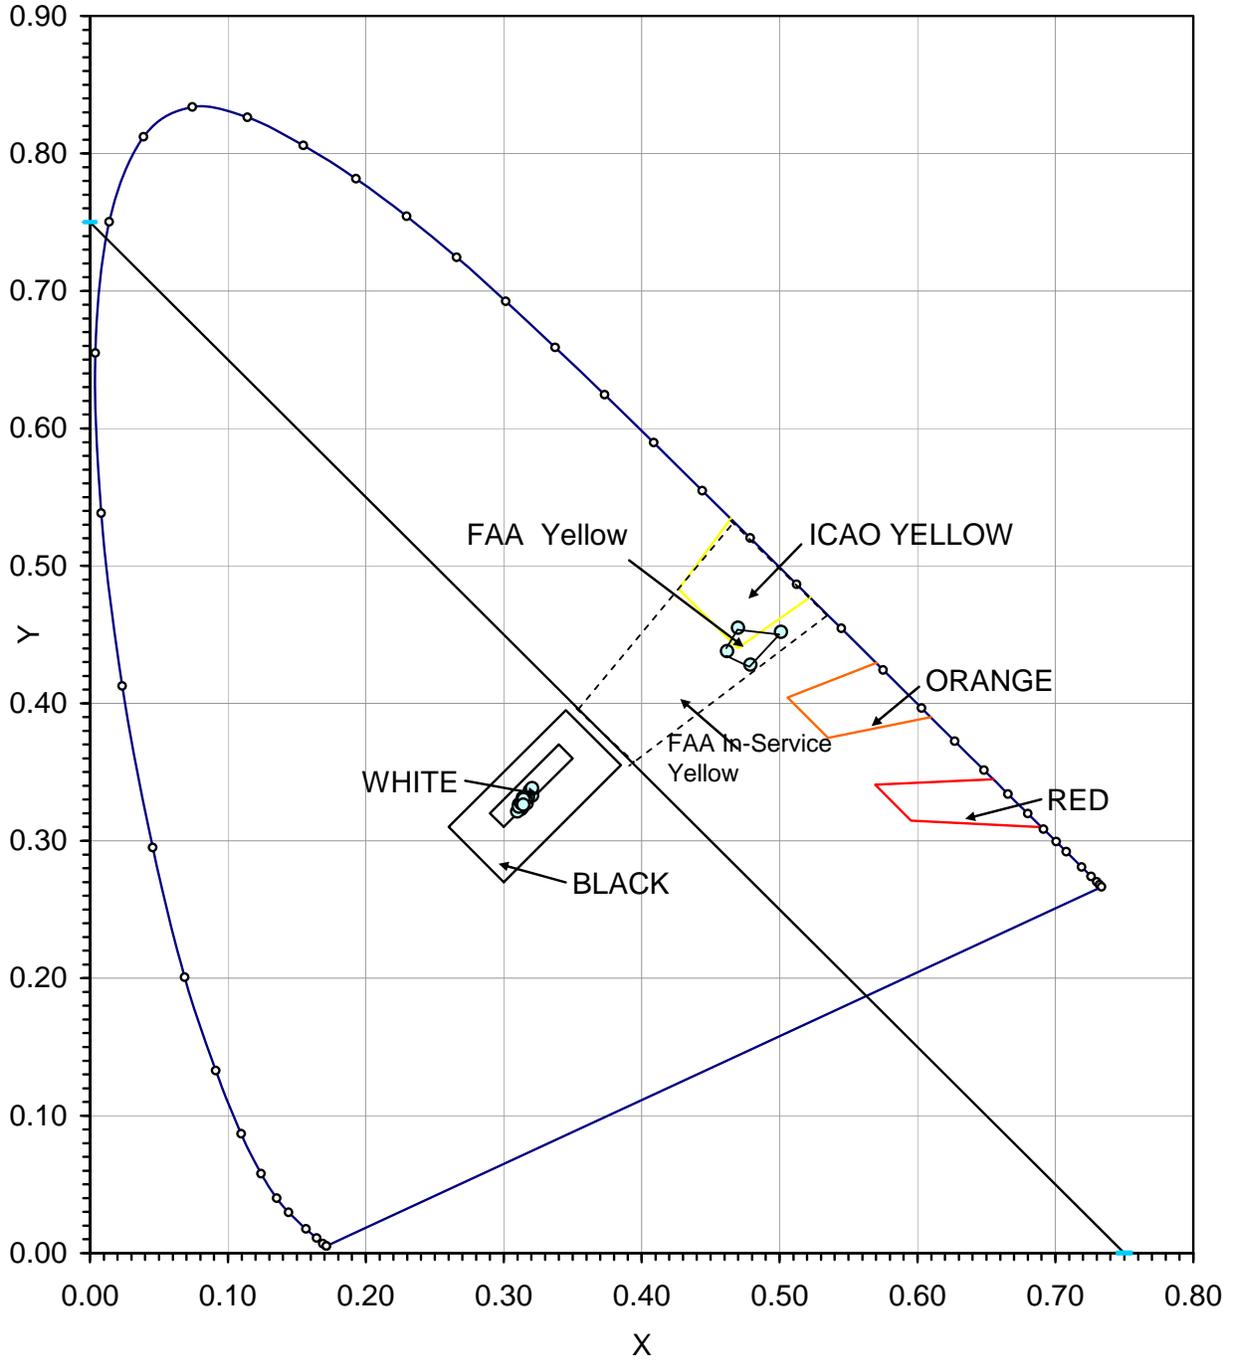
Figure A-51. Chromaticity Readings of CCRID, Black Paint at EWR
